# NORTHERN VENTURA COUNTY COASTAL WATERSHED PROJECT

Prepared by Blue Tomorrow and

Dr. Arturo Keller at the University of California, Santa Barbara

On behalf of the Rose Foundation for Communities and the Environment

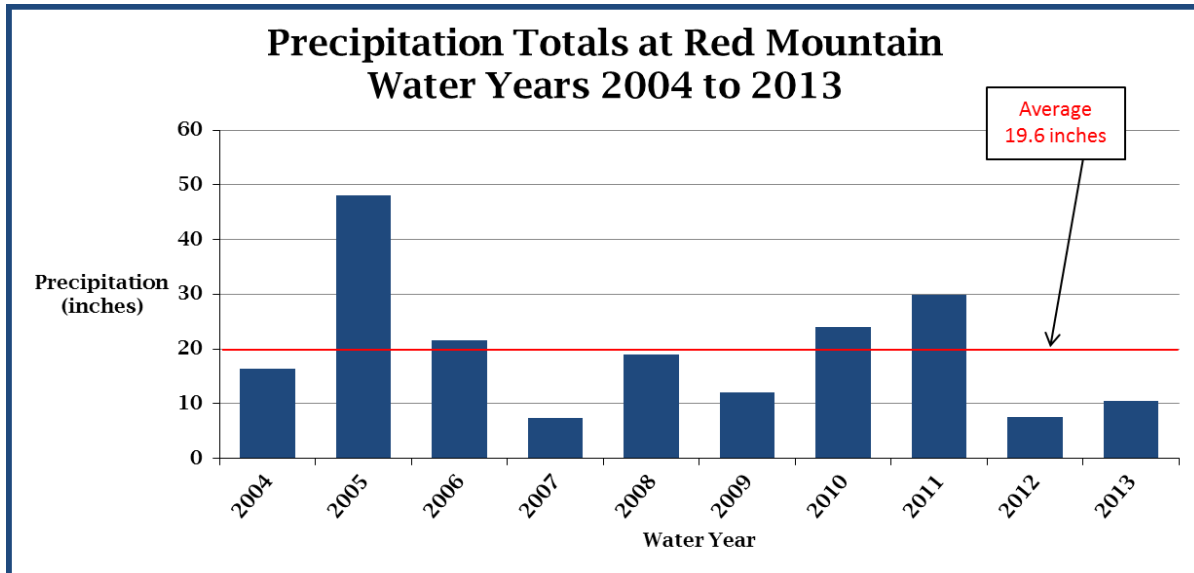
**Figure 3.3** – Water year precipitation totals at Red Mountain since the gauge became active in 2003<sup>1</sup>. The average precipitation at this gauge over the 10 year interval was 19.6 inches. The greatest water year total was 48.07 inches during the 2005 water year. A water year extends from October to September.

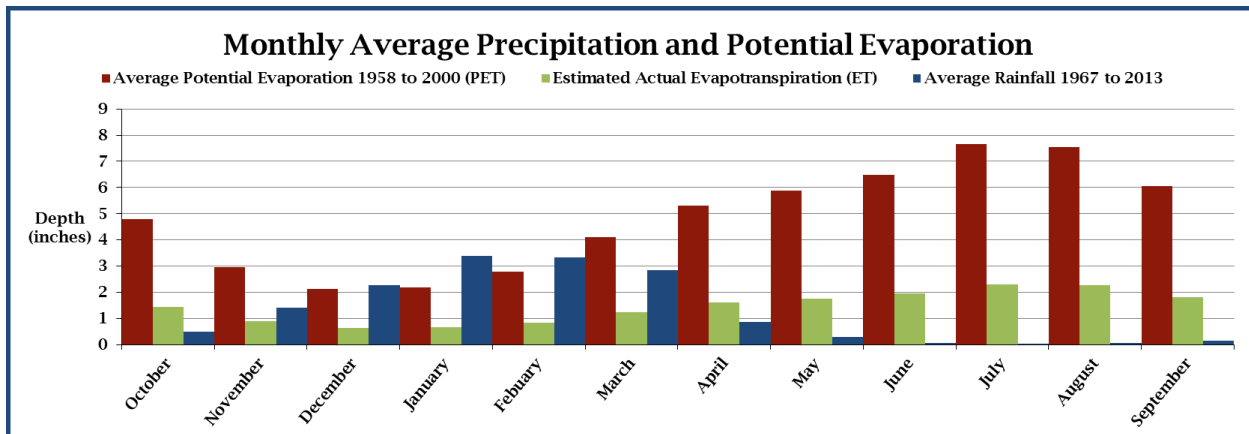
**Figure 3.4** – Monthly average rainfall at the base of Madriano Canyon (blue) from 1967 to 2013 and monthly average potential evaporation (PET) from a class A pan at the base of Casitas Lake (red) from 1958 to 2000<sup>1</sup>. The estimated actual evapotranspiration (ET) is 30% of the average potential evaporation (PET).

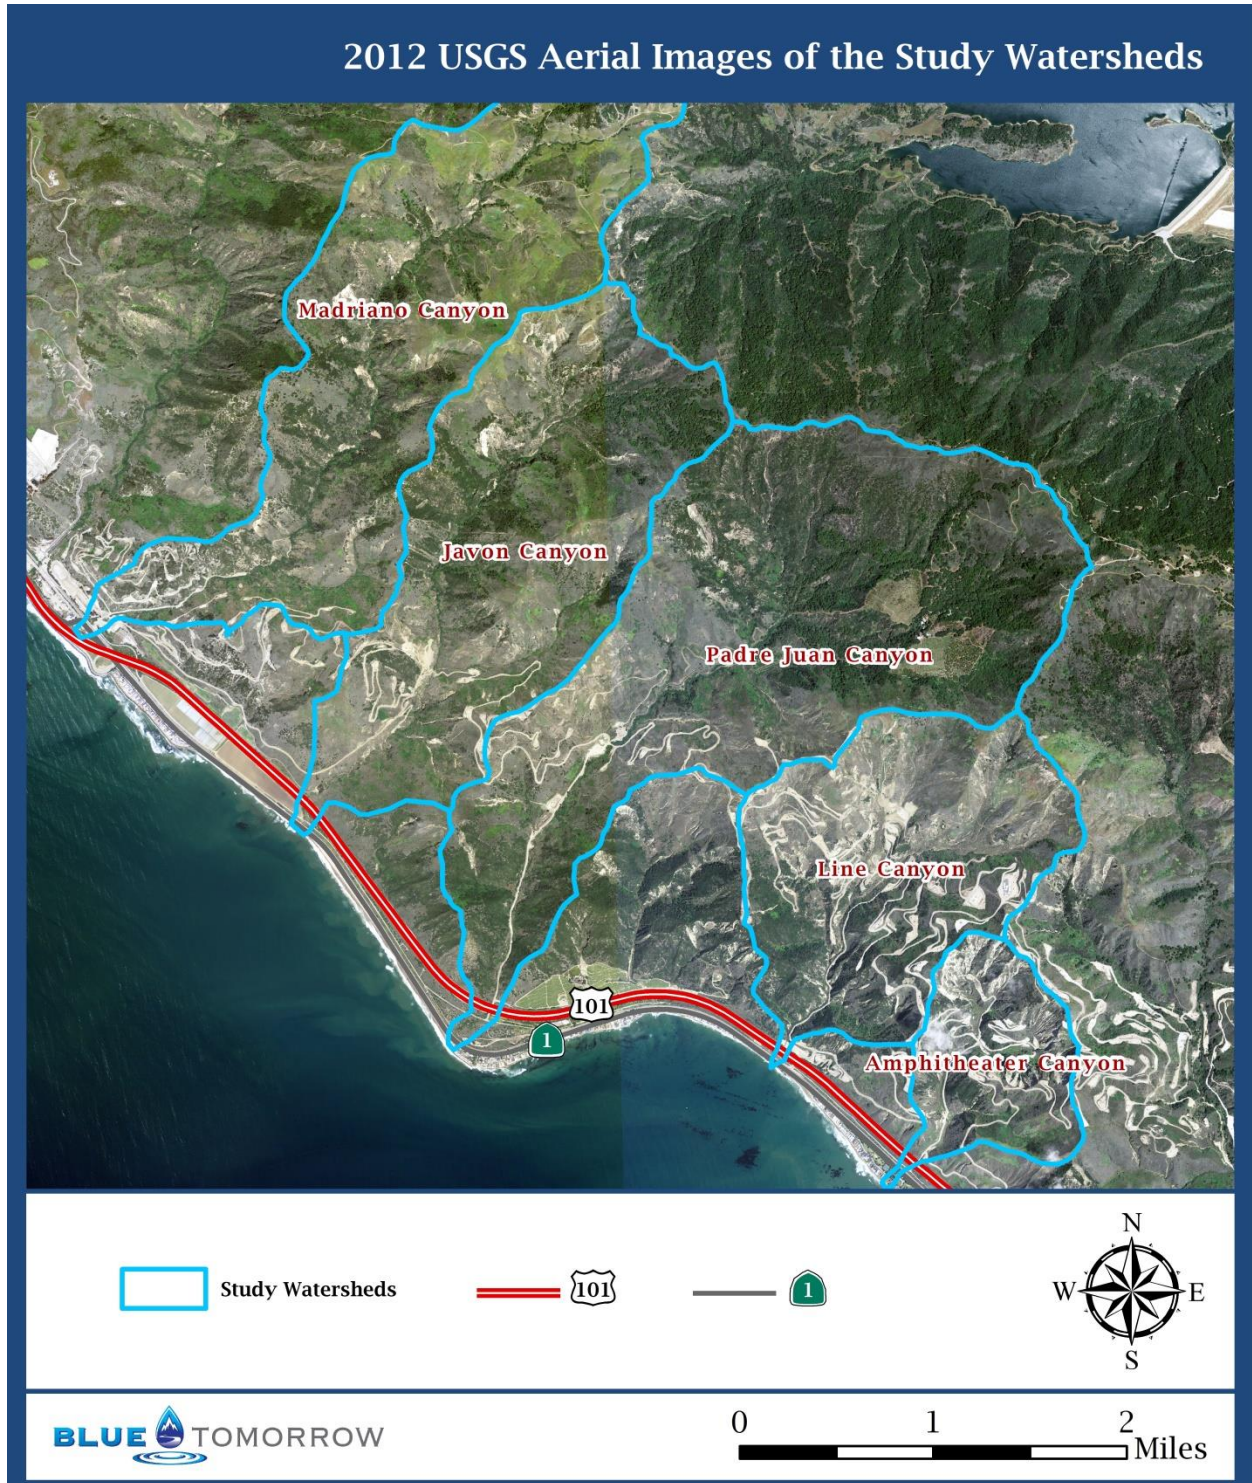
**Figure 4.1** – 2012 USGS aerial images of the study watersheds show the distribution of different vegetation types. The large extent of oil field development can be seen in Line and Amphitheater Canyon. The darker vegetation in the upper reaches of Padre Juan Canyon is oak woodlands and chaparral on steeper slopes. The largest areas of grassland are the lighter green areas at the top of Madriano Canyon.

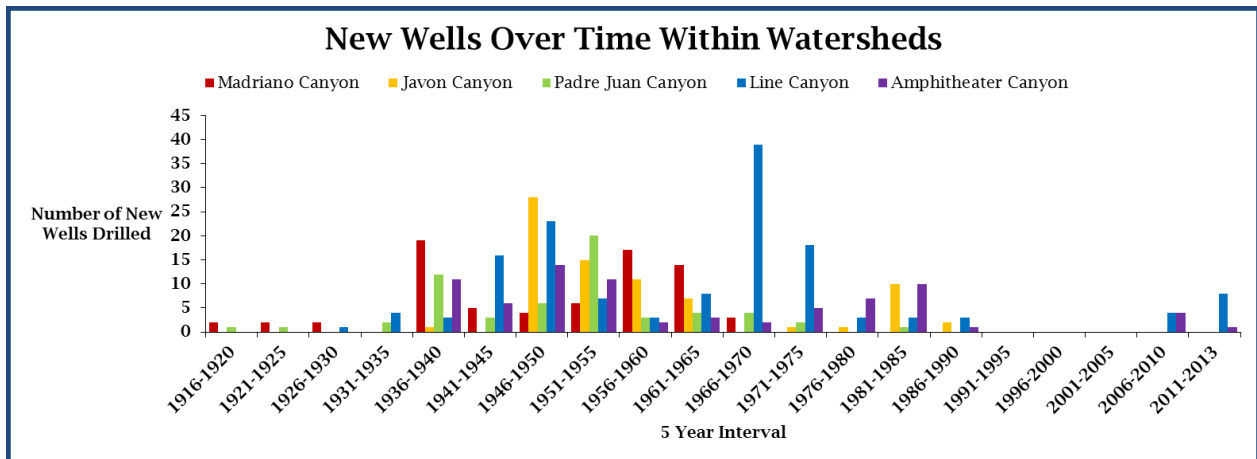
**Figure 8.3** – New wells drilled within each watershed from 1916 to 2013. Current well status is not considered. Data is from the California Division of Oil, Gas, and Geothermal Resources (DOGGR), downloaded September 2013<sup>1,3</sup>.

The total number of new wells drilled in the watersheds quickly peaked from the late 1930s to the late 1940s and then slowly declined (Figure 8.2). The resurgence of activity in the late 1960s was due to the development of two new oil zones between 12,000 and 15,000 feet deep beneath Line Canyon in the Rincon and San Miguelito Grubb lease<sup>2</sup> (Figure 8.2 and Figure 8.3).

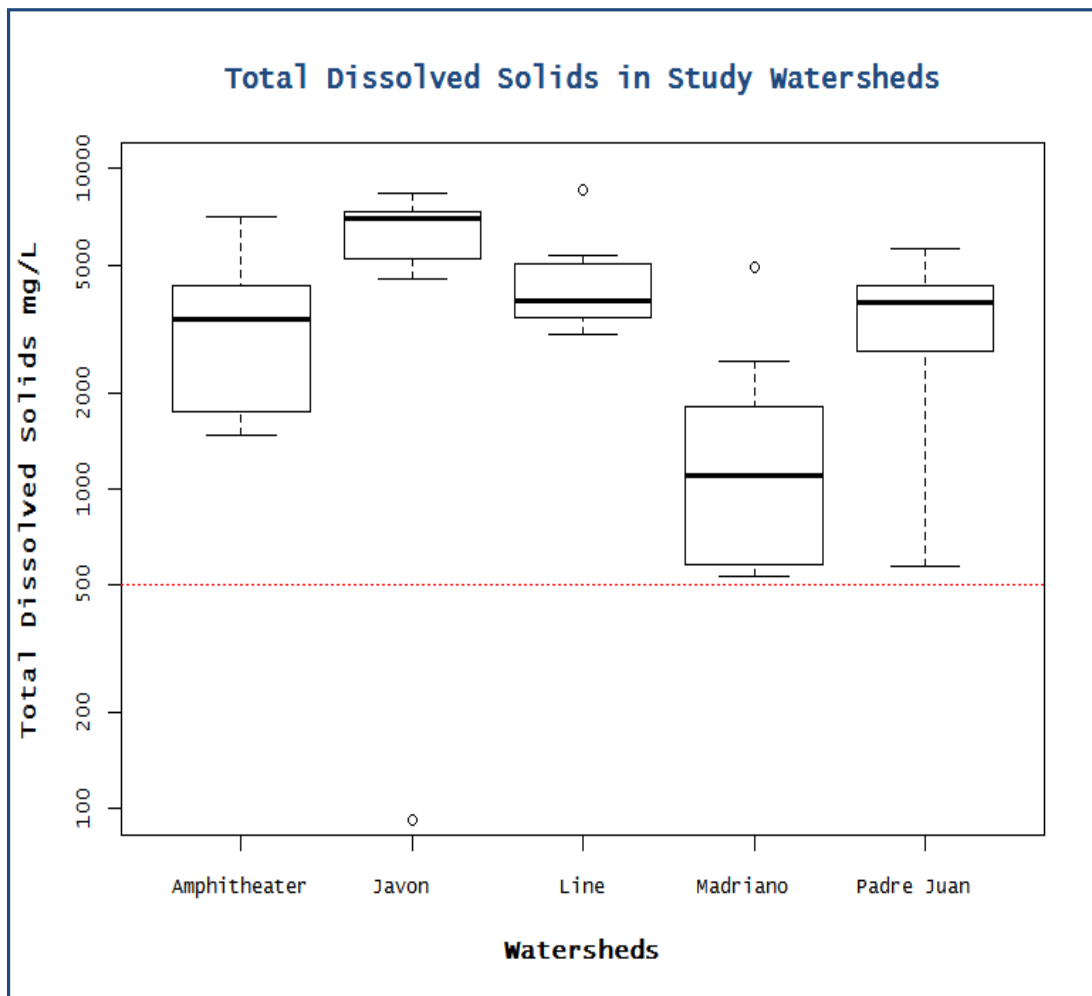
Total Dissolved Solids (TDS) levels were measured from eight samples taken by Vintage/Oxy from the Amphitheater, Line, and Javon Canyons by Vintage/Oxy from January 27, 2007 through May 17, 2011. Seven samples were collected and analyzed from Madriano and Padre Juan Canyons from in the same timeframe<sup>7</sup>.

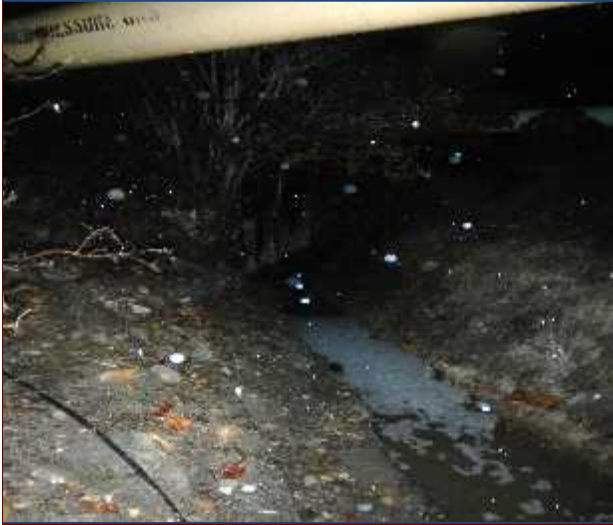
First flush event on November 21, 2013 at 1:00 am
